CARR-1149

Benjamin Bowser Farm
4864 Schalk Road One
Alesia (vicinity)

Maryland Historical Trust State Historic Sites Inventory Form

4864 Schalk Rd #1 CARR-1149
Site Plan

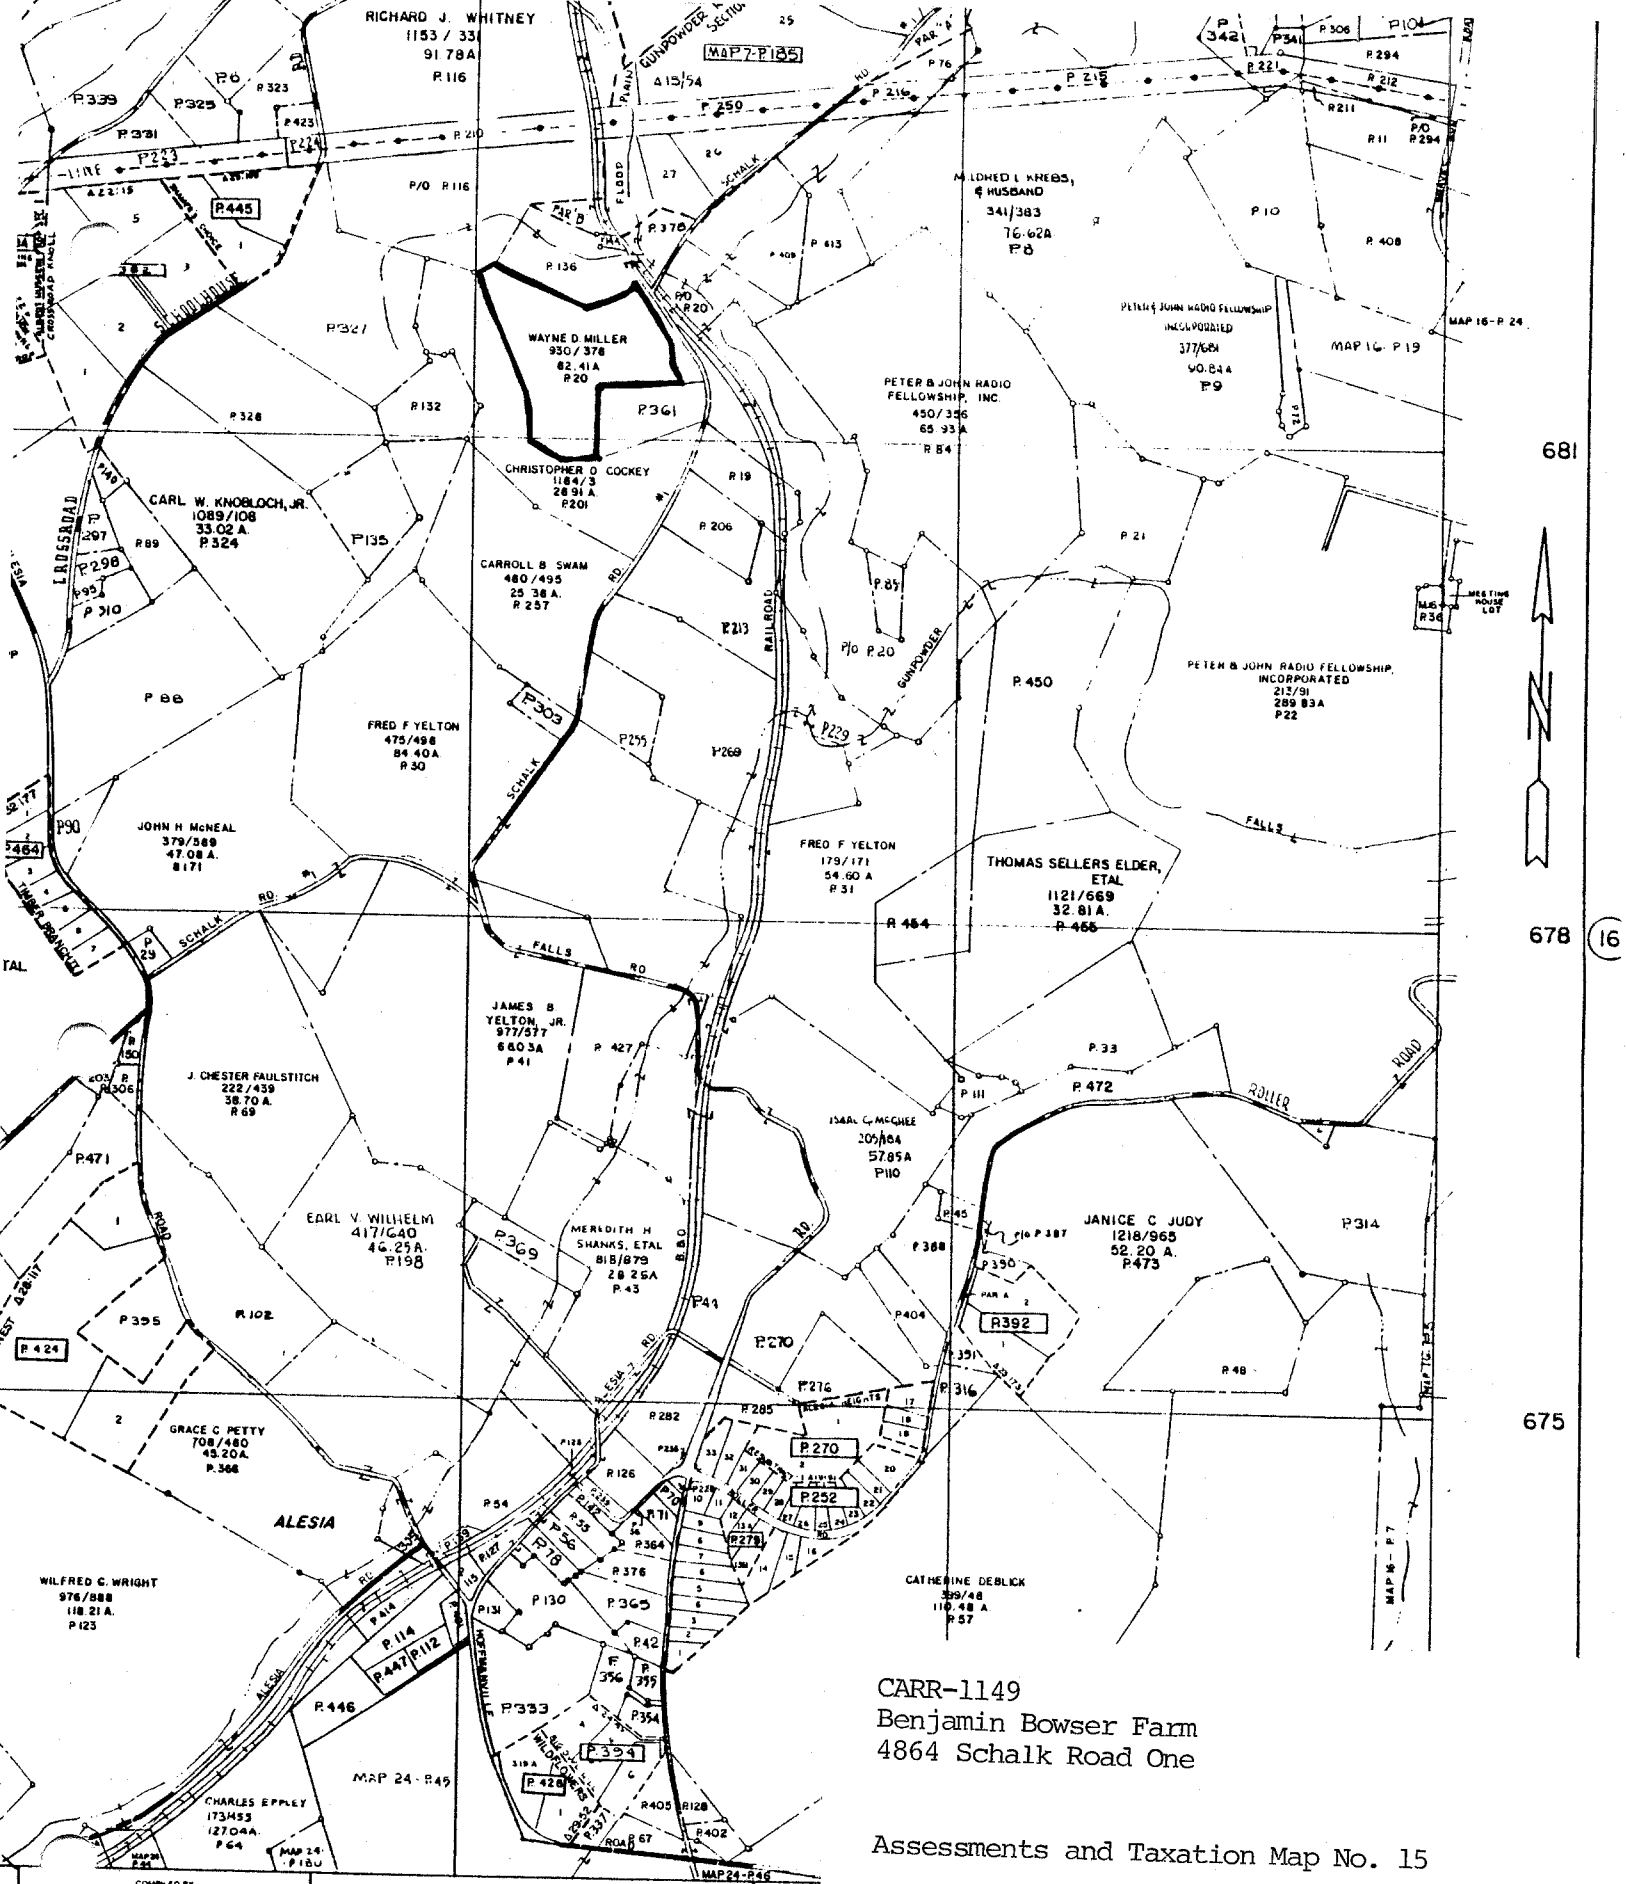
The Benjamin Bowser Farm is located on the west side of Schalk Road One approximately one-and-one-half miles north of Alesia and one-and-one-half miles southeast of Lineboro. The farm complex is laid out on a linear plan at the base of a steep ridge, and consists of a brick house built in 1878, a brick smokehouse, a stone and frame summer kitchen/springhouse, a frame shop building, frame wagon shed with attached privy, corn crib, hog pen, and bank barn with attached poultry house wing.

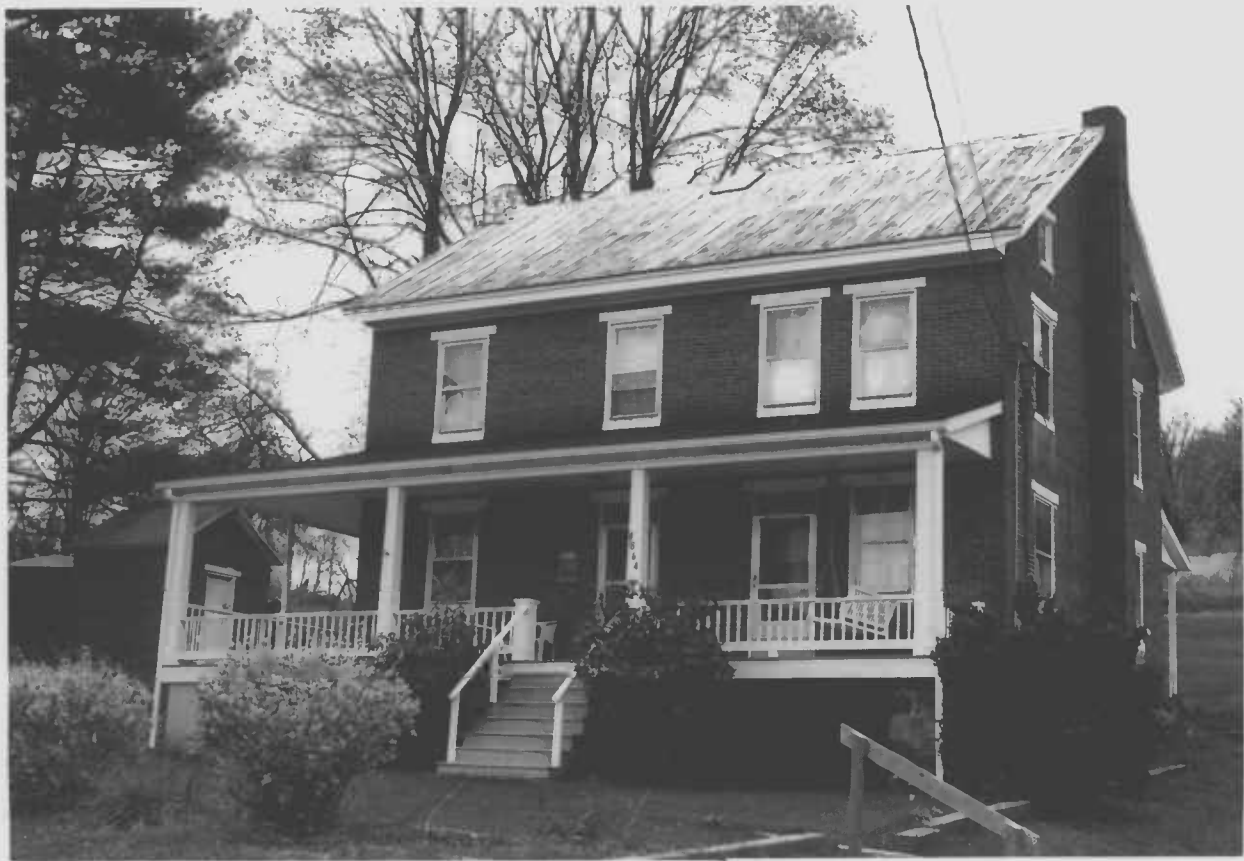
1/11

The house faces east, toward Schalk Road, and is a two-story, four-bay by two-bay building of 5-1 common bond brick on a rubble stone foundation. It is banked into the hill on the west. The exposed east cellar wall has one six-light sash in the south bay. The first story has two center entrances with three-light transoms and doors with one light over two vertical panels. The windows have 2/2 double hung sash with beaded-edge frames, and wood sills, lintels, and corner blocks. The openings are not spaced regularly, the two north bays being close together. The gable roof has inverted-V-seam

House - east : north elevs.

metal and a boxed cornice. There is a raised one-story porch that wraps around the east, south, and west elevations. Stone and brick piers support the deck. The posts on the east have been boxed and the balusters on the south replaced, but original posts survive on the south. They are chamfered, with tripartite capital blocks. The original balusters on the east are vertical, and are square in plan. The steps are off the center of the east porch. The south elevation of the house is two bays, with two small four-light windows in the gable end and a semicircular date panel painted "Built 1878 By B. Bowser." Between the first story windows is a smaller one-light sash with a bullnose frame, and wood sill, lintel and corner blocks. The mortar joints show evidence of striping, some of which is missing around the small window, suggesting it was cut into the wall later, and new bricks toothed in. There is a door in the eastern-most end of the south elevation of the cellar. The north elevation has identical windows in the gable, but has an external brick chimney centered on the wall, and a six-light sash in the east bay of the cellar. An old aerial photograph in the owners possession shows an internal brick chimney at each end, and apparently a wood shingle roof. There were no steps east of the porch, which had six posts and balusters between them across the whole front.

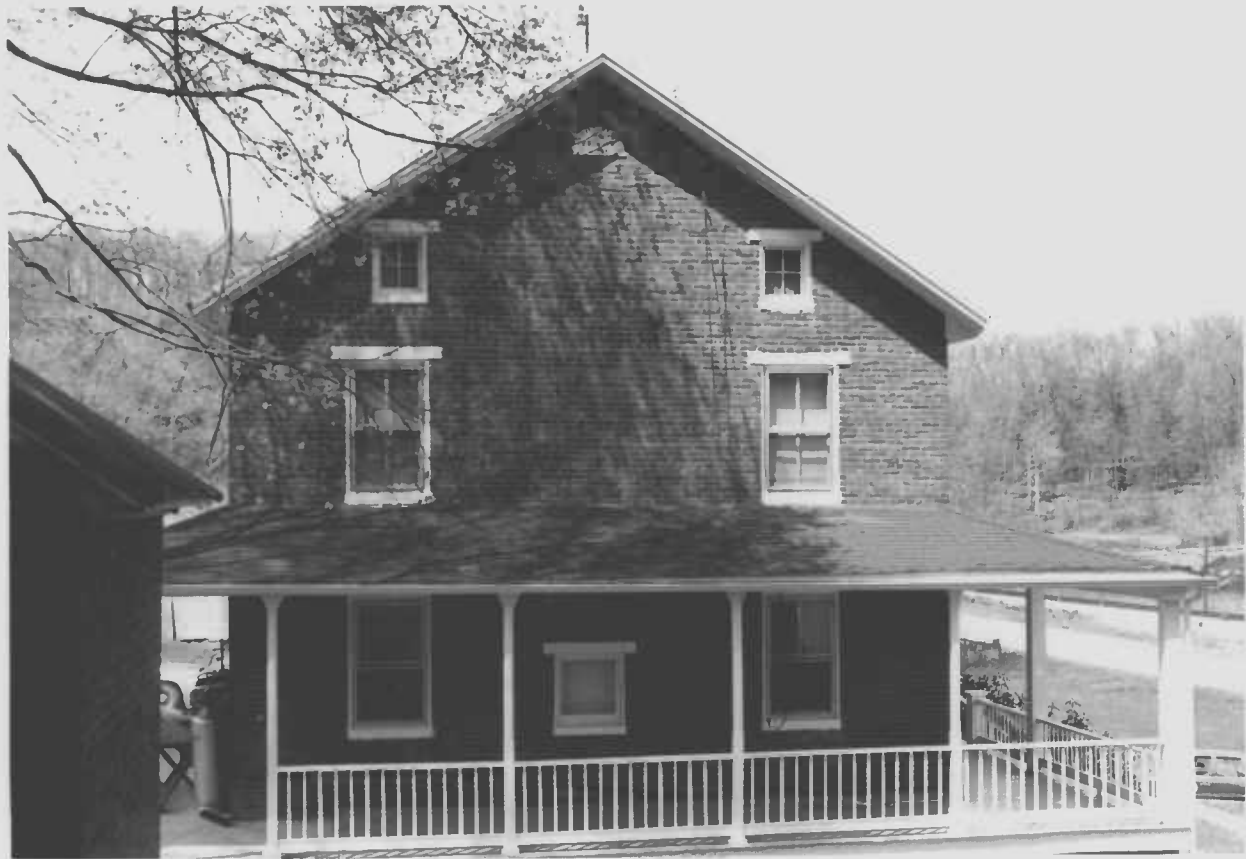
2/11

Neg. Loc.: Maryland Historical Trust
House - south elev.

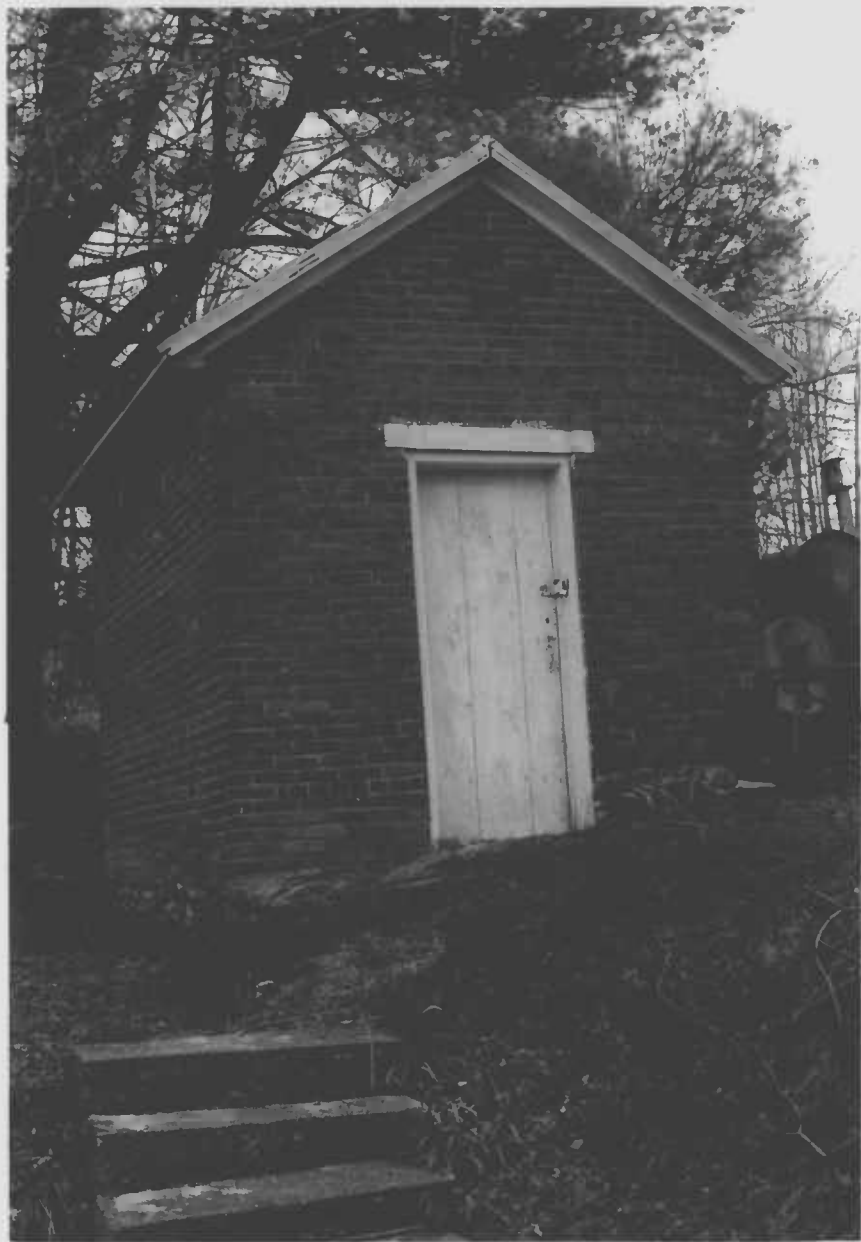
South of the house is a 5-1 common bond brick smokehouse on a rubble stone foundation. The north elevation has a vertical board door with wood lintel and corner blocks. Above four bricks were omitted in the gable end for ventilation, but these are

now filled by loose bricks. The same arrangement is on the south gable end, as well. The gable roof has an inverted V-seam covering and a box cornice. The interior retains its tree, which is a square post with three levels of racks. Each rack has four arms that support a diamond frame holding the hooks for the meat. The remains of a large brick fire pit are inside.

Neg. Loc.: Maryland Historical Trust
Smokehouse - east: north elevs.

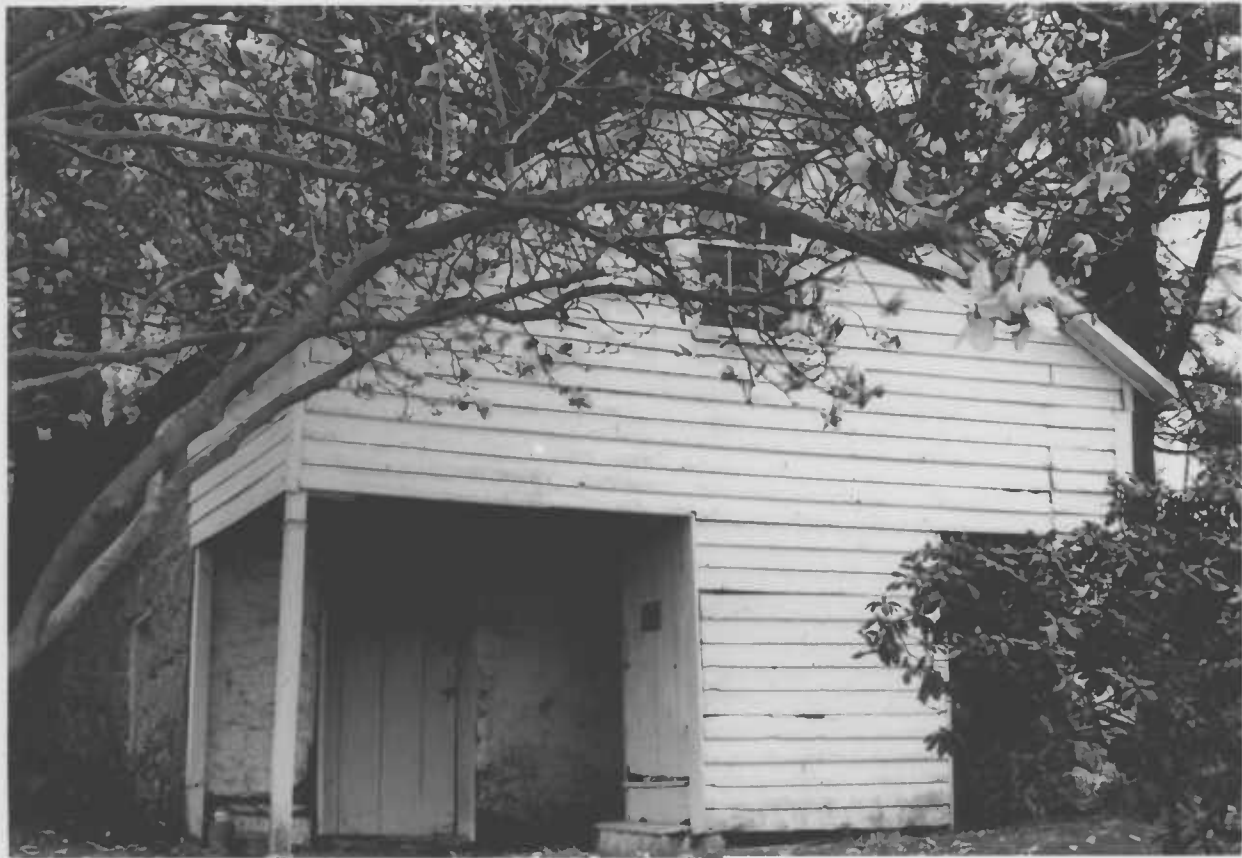
1/11

East of the smokehouse is a stone and frame combination springhouse and summer kitchen banked into a hill on the southwest corner. The building is a rubble stone one-story structure with a cantilevered frame attic on the north side that is clapboarded. There is a 6/6 double hung sash in the north gable end. Under the cantilevered section is an enclosed stair that is centered east to west on the north wall, and is flush with the north wall of the attic above. The clapboard is carried down to cover only the central section below the attic, where the stairs are. On the east side of the enclosed stairs are two risers and a vertical board door above them that leads to the remaining stairs. The sections east and west of the stairs, under the cantilevered north wall, are left open. The east bay of the north elevation has a vertical board door in a mitered wood frame set in the stone wall under the cantilever. There is a square wood post under the northeast corner of the cantilever. The east elevation has a 6/3 double hung sash north of center in the stone section. The east wall of the cantilevered section is covered in clapboard. The south elevation has clapboard in the gable end, with a 6/6 sash west of center. The west elevation has six-light sash north of center and a brick wall on a stone foundation from ground level to the plate of the cantilevered section. The stone and brick are not tied into the stone wall of the main structure, and are severely cracked. The north end girt of the cantilevered section projects through the brick wall.

Neg. Loc.: Maryland Historical Trust
Springhouse / Summer Kitchen - east: north elevs.

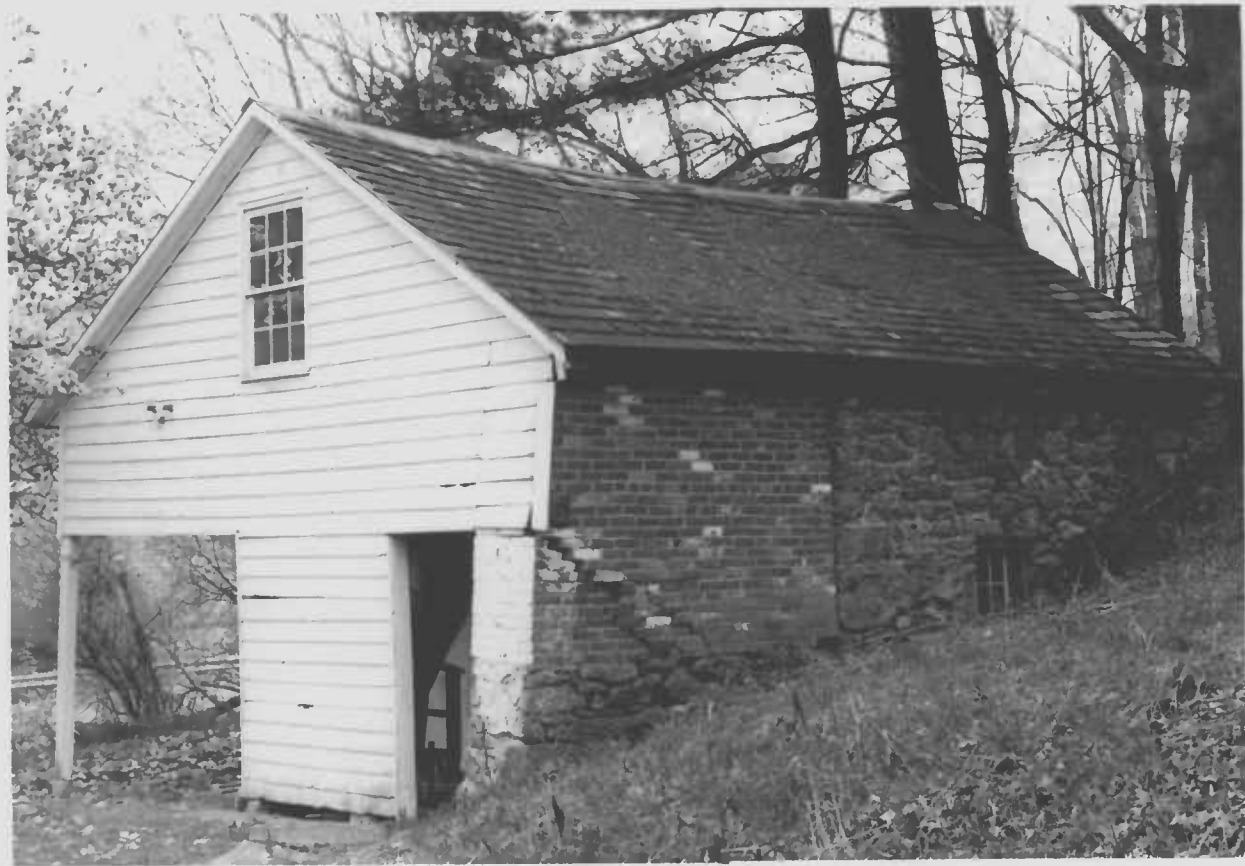
5/11

The lower story has plastered walls inside and a concrete floor with concrete trough on the west wall. There is a large brick fireplace in the southeast corner with a wood mantel tree and the original cranes still hanging in it. The joists are hewn on top and bottom. There are wood lintels over the windows and doors in the interior. In the attic story the brick chimney is corbelled toward the ridge but the top has collapsed and no longer projects through the roof. The stone walls project about 2½ feet above the floor level. The large plates are one piece, spanning the entire length from the south wall to the end of the north wall of the cantilever. The north attic girt is hewn and has a central tenon set in a mortise in each plate and pegged. The framing on the north end is nailed. The rafters are sawn and mitered at the ridge.

Springhouse / summer kitchen - north & west elevs.

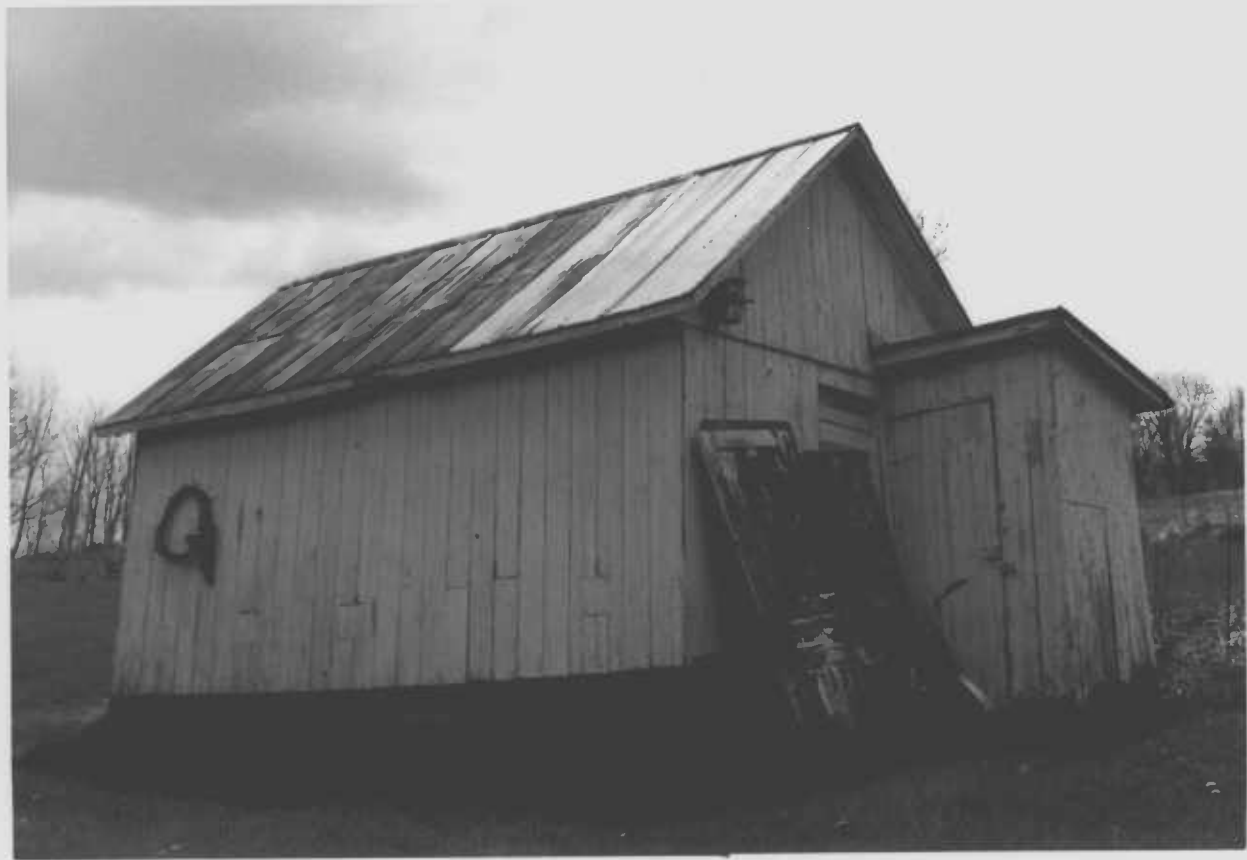
6/11

North of the house is a wagon shed with nailed 2x4 frame and beaded-edge-and-center vertical board siding. The south end is open, only the pintles of the former doors that were here surviving. The shed is set on wood piers and has a gable roof with

corrugated metal on the west half and inverted V-seam on the east. On the north end is a boarded-over opening in the center, and a privy attached to the wall west of the opening. The siding, and the door on the east, are the same as the wagon shed. The shed roof of the privy is inverted V-seam.

Shed: privy - east: north elevs.

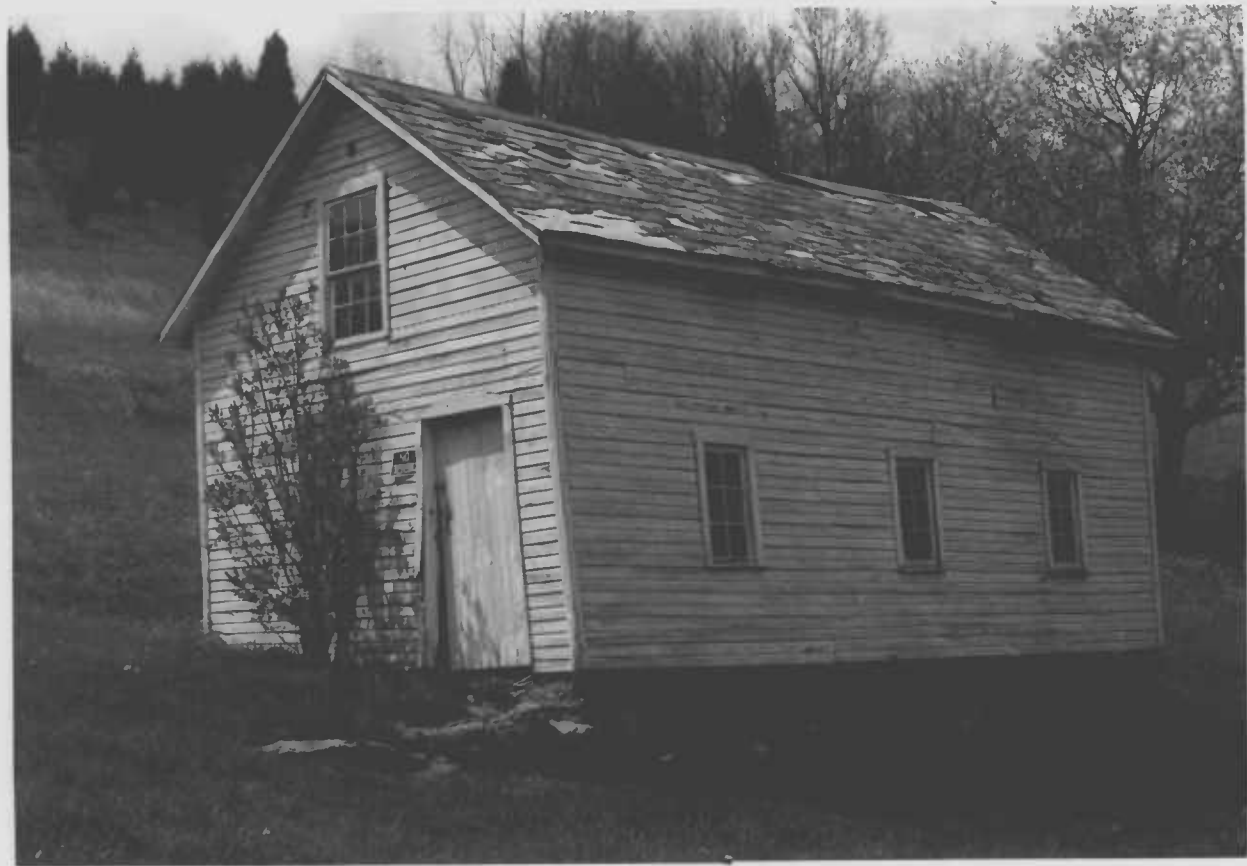
7/11

Just north of the wagon shed is a frame shop building with slate gable roof and rubble stone foundation. It is one bay by three bays, with an east-of-center entrance on the south gable end, and a 6/6 double hung sash in the center of the gable end. It is one-and-one-half stories tall, having a raised attic, and is covered in German siding. The door is of vertical, beaded-edge-and-center boards. The east elevation has three six-light sash. All openings have flat surrounds with gabled tops. The north elevation has a 6/6 sash centered in the gable end. The west elevation is vertical boards with several openings cut into it. The shop is built of 2x4 studs on the east and 4x4 studs on the west. The studs are full height, with 1x6 clamps nailed to them and 2x6 sawn joists that rest on the clamps. The floor is concrete. There are three posts down the middle of the building, on a north-south line. The straight run stairs begin in the northeast corner and run along the north wall. There is a trap door at the top of the stairs. The rafters are circular sawn 2x4's that are mitered at the ridge.

Neg. Loc.: Maryland Historical Trust
shop - south: east elevs.

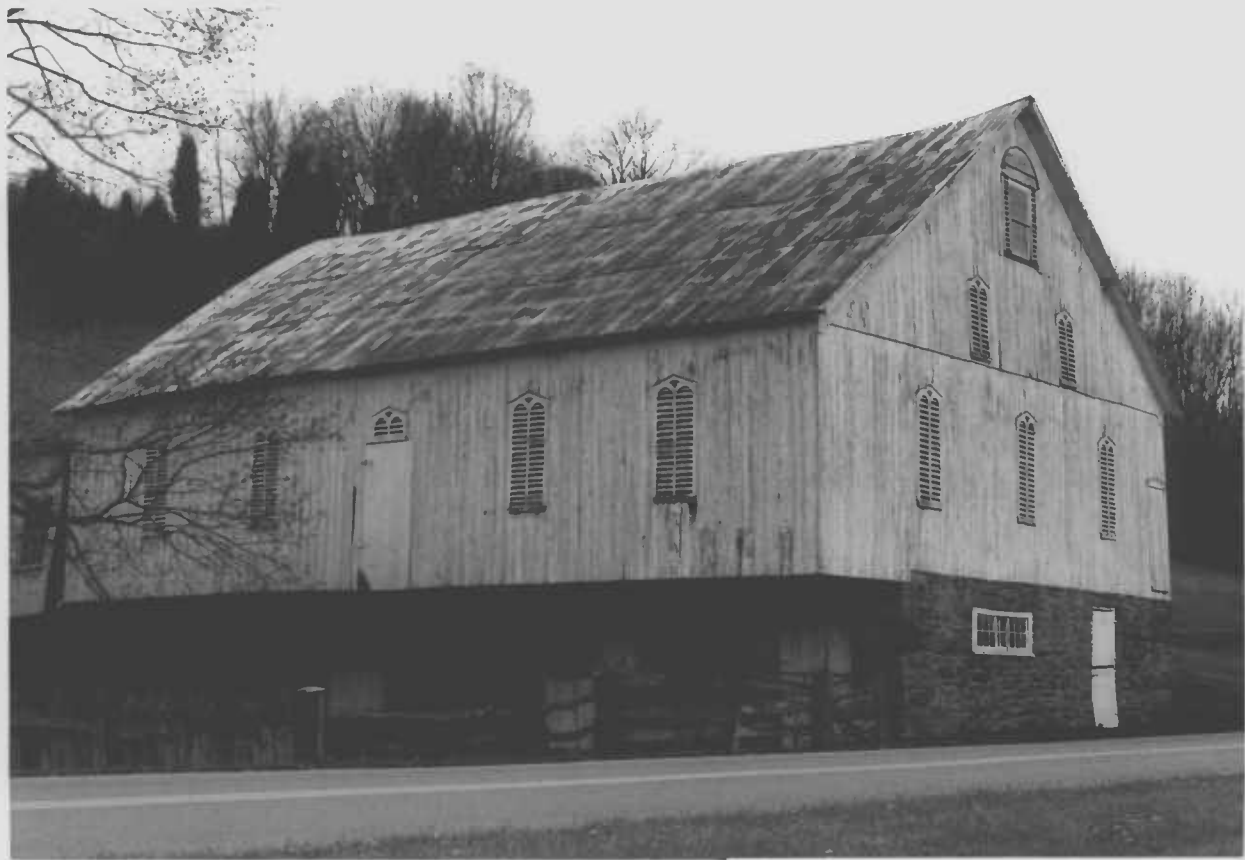
8/11

North of all these structures, and set very close to the road, is the barn complex. The banked barn has the forebay facing south. The foundation is of rubble stone on all sides, with quoins at the corners. The lower story of the south elevation has a vertical board dutch door on strap hinges, a wood vent with louvers of diamond section, a beaded-edge vertical board dutch door on strap hinges, a similar vent, stone infill where a door was formerly, and two more vertical board dutch doors on strap hinges separated by a similar wood vent. The upper story is five bays, with two gabled wood vents at each end and a center door with the top portion of a gabled vent set above it. The siding is vertical, beaded-edge-and-center, tongue-and-groove boards. The east elevation has a new window in the south bay, with a four-light sash between two six-light sash. The north bay has a beaded-edge-and-center vertical board dutch door on strap hinges. Above is a row of three vents, and a door with gabled surround in the north corner. Above this is a row of two vents, and in the gable end a 6/6 sash with wood vent on either side, all topped by semi-circular wood trim. The north elevation has the ramp. The east bay of the lower story has an adjustable wood-louvered vent. In the upper story a six-light window with gabled surround flanks each side of the center double wagon doors. These doors match the siding, and have a smaller door inset in the west door. The west

elevation has one 6/6 sash with gabled surround in the gable end. There is a foundation for a silo here, with rubble stone set on a brick base, and an opening into the lower story. Attached to the southwest corner of the barn is a poultry house. The interior of the lower story has been altered some, but retains the feed boxes, troughs, and hay racks. The large joists are hewn on top and bottom, and are supported by two summer beams. The upper story has a central threshing floor with a hay mow on each side and a granary in the northeast corner. Some of the original framing has been cut out, and some new members have been added. There are three-quarter round log rafters joined at the ridge with a central tenon in mortise, and pegged. The roof has several wind braces of small section.

Barn - South : east elevs.

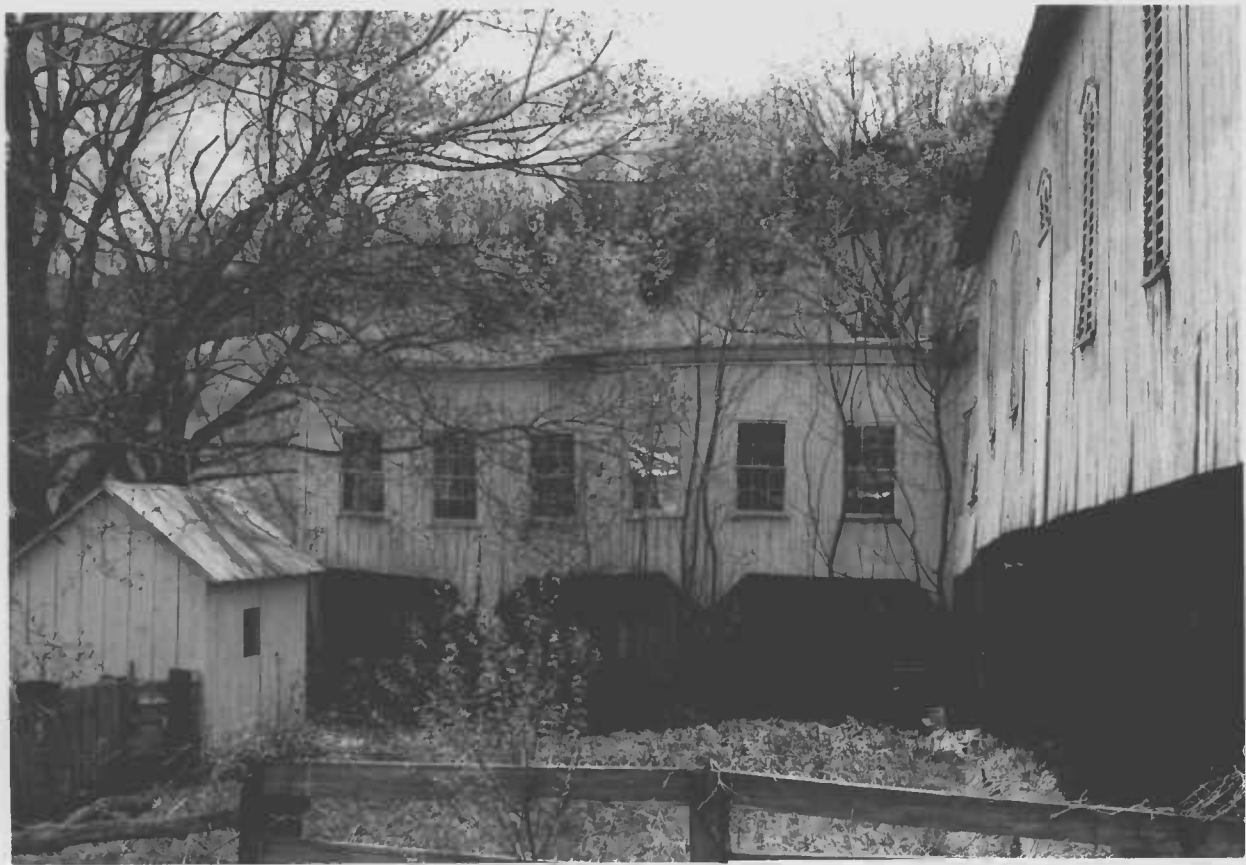
9/11

South of the barn is a vertical board, wood-shingled gabled-roof hog pen. It has a large door and a small door on the west, and one low opening for hogs on the east, at the south corner. This building helps to define the barnyard. There are the remains of fences west of the pen to the poultry house, and east of the pen to the road. Part of the eastern section of fence is wide, picket cut boards on horizontal rails. Horizontal rail and horizontal board fences and gates run along the road and enclose the east side of the barnyard.

Hog pen, poultry house, & barnyard - vw. from east

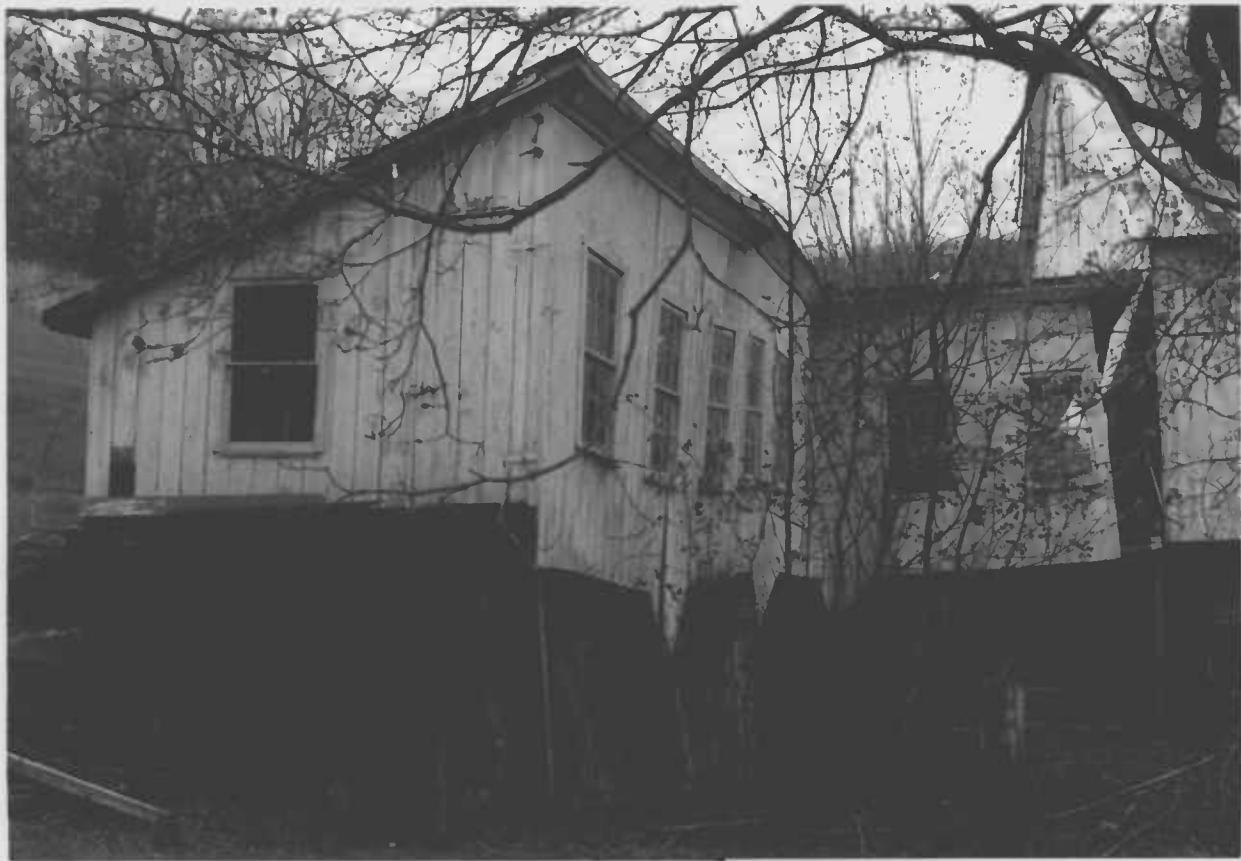
10/11

The poultry house is a large ell that encloses the west end of the barnyard. The short section of the ell is attached to the barn, with the long section running south from the end of it. It is two stories and is banked into the hill, with a stone wall on the west and north sides of the lower story. The south and east sides are open, and have posts with braces that support the structure above. The upper story has a shed roof, with vertical board and batten siding on the north and west and beaded-edge-and-center vertical board siding on the south and east. The south elevation of the long section has a 6/6 sash and a board door to match the siding, while the short section has two 6/6 sash. The east elevation of the upper story has six 6/6 sash. The joists are hewn top and bottom, but the frame and rafters are sawn and nailed 2x4's. The west side of this structure is collapsing and it is slated to be demolished this summer (1992).

Poultry house - South & east elevs.

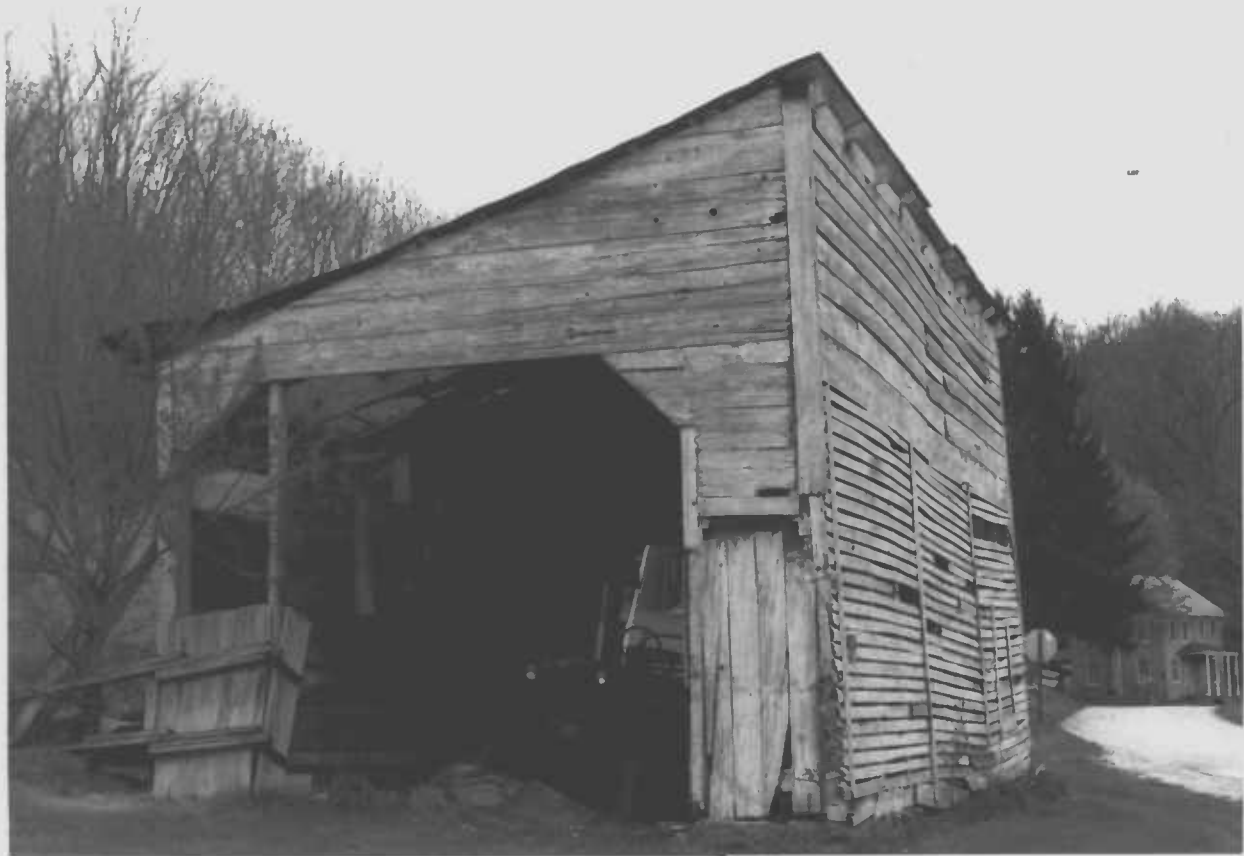
11/11

North of the barn is a wagon shed with corn cribs on the east and west sides, and open ends on the north and south. It has a shed roof with inverted V-seam on lath. The foundation is dry-laid stone. There are horizontal laths on the east and north sides, with clapboard above. The west and south sides have clapboard only, with a vertical board door to each crib on the south side. The west crib has been rebuilt. The structure is built of sawn and nailed 4x4's.

Neg. loc.: Maryland Historical Trust
corn crib - south: east elevs.
